Manhole Inspection Summary

Manhole # S150O1024MH

Insp Date: **6/20/07 9:48 AM**

Location Address: **2604 GREENSPRING AVE**

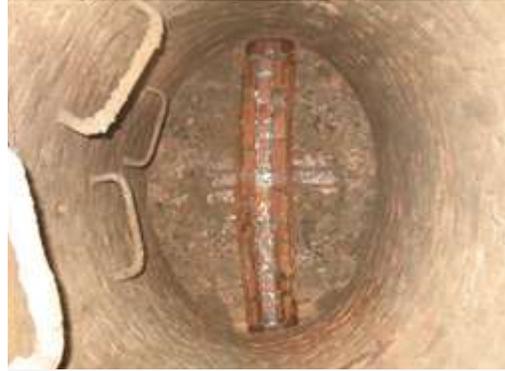
Top View

Corroded steps. Evidence of surcharge - Bench debris.

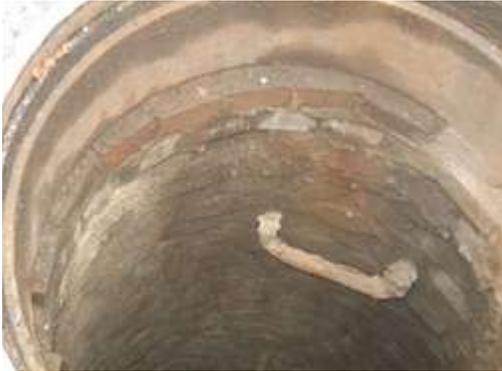
Defect

Frame leaks. Adjustment deterioration and infiltration. Corbel infiltration - other side.

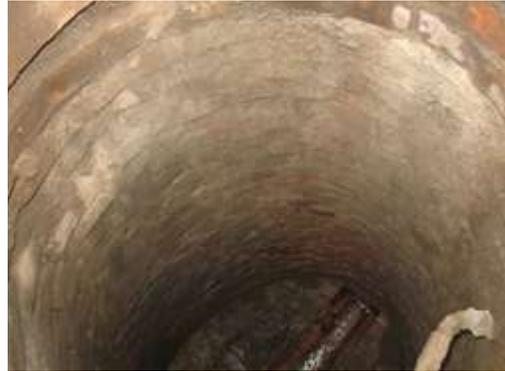
Defect

Frame leaks. Adjustment deterioration and infiltration. Corbel infiltration.

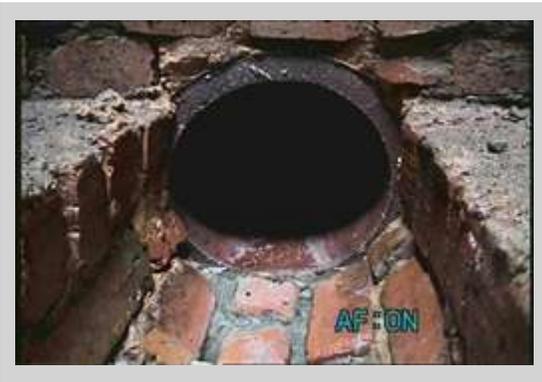
8 in. Circular Gravity Sewer Pipe Out @ 12 O'Clock

Channel deterioration.

Infiltration: **Evidence** Pipe Seal Cond: **Unknown**

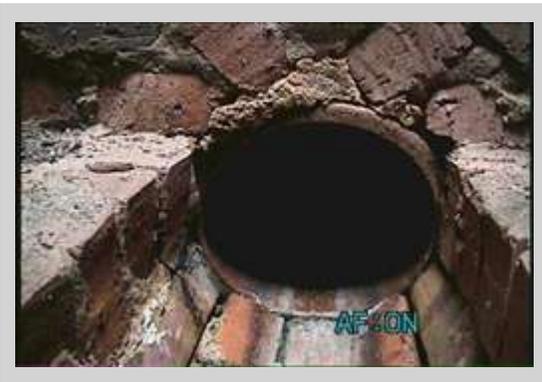
8 in. Circular Gravity Sewer Pipe In @ 6 O'Clock

Infiltration: **Evidence** Pipe Seal Cond: **Broken**
